## How to manage UL Power Supply for Lumberg Active Components

Carmine D'Errico - 2019-08-22 - How-to articles

**Affected Modules** 0980 ESL 390-1x1

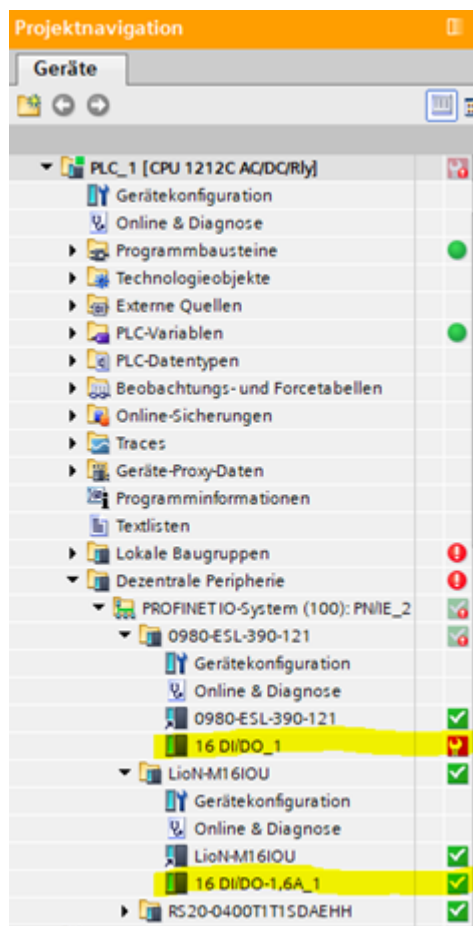
Now we switch off the UL Power Supply for both the modules

We notice that module 0980 ESL 390-1x1 shows an error. These are the reasons:

- The module provides an option to manage the error propagation for **UL upstream power supply**
- The module provides the option to manage the propagation **UL Power Supply error for downstream components**

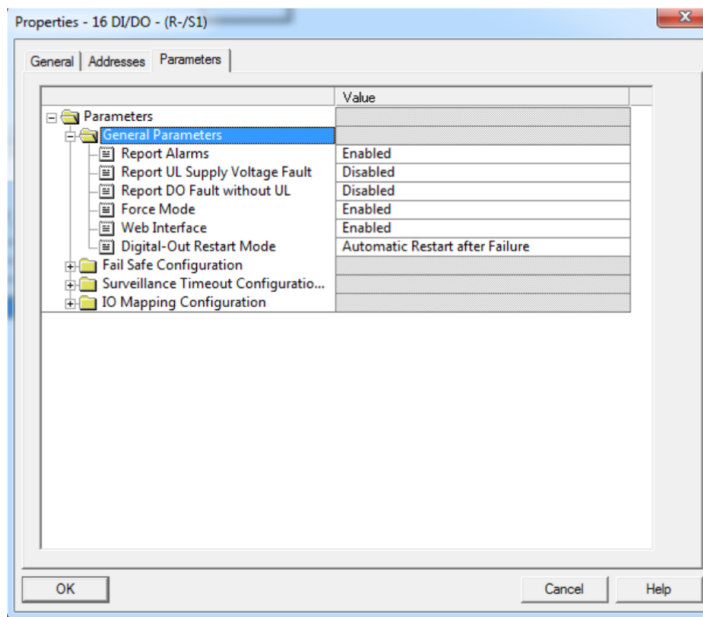
No Diagnosis without UL and activated Output

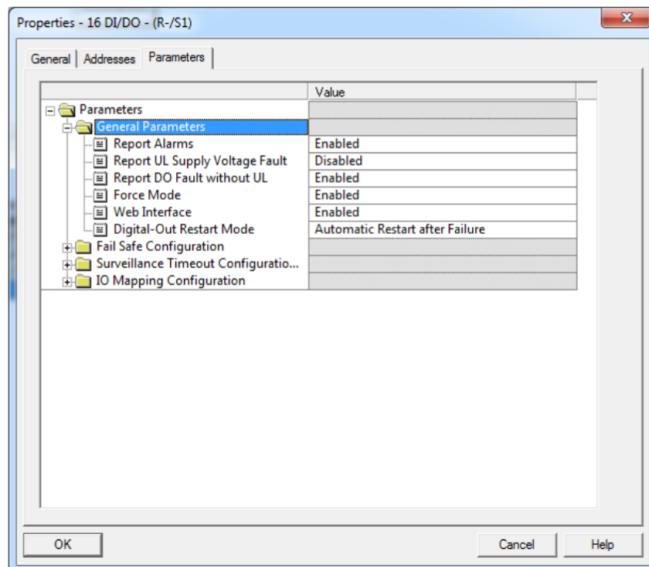
Diagnosis without UL only for activated Output

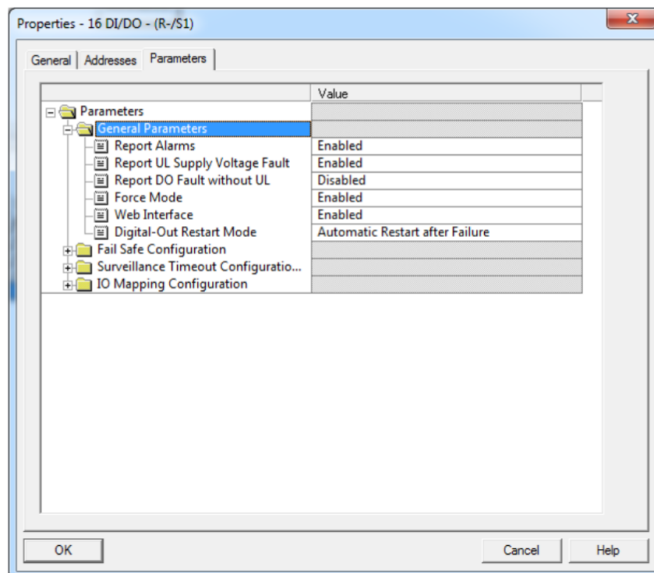
UL diagnosis when off or below 18V
