## How to manage UL Power Supply for Lumberg Active Components

Carmine D'Errico - 2019-08-22 - How-to articles

<b>Affected Modules</b>	0980 ESL 390-1x1
<b>Network type</b>	Profinet
<b>PLC</b>	Siemens

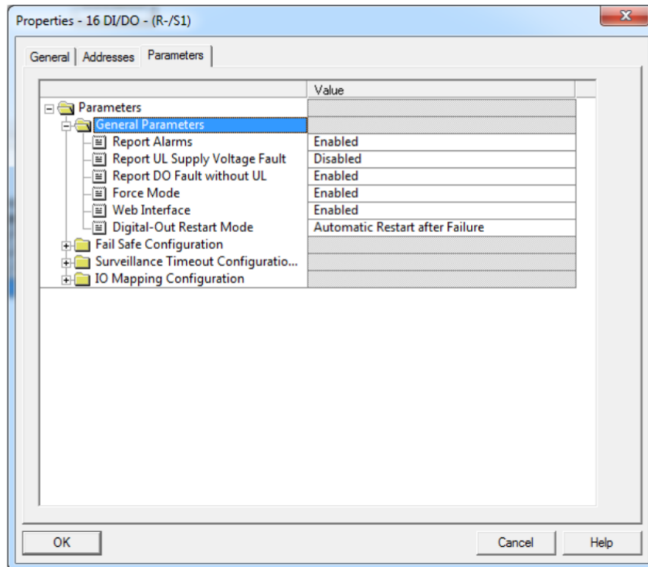
Diagnosis without UL only for activated Output
