How to manage UL Power Supply for Lumberg Active Components

Carmine D'Errico - 2019-08-22 - How-to articles

Affected Modules 0980 ESL 390-1x1

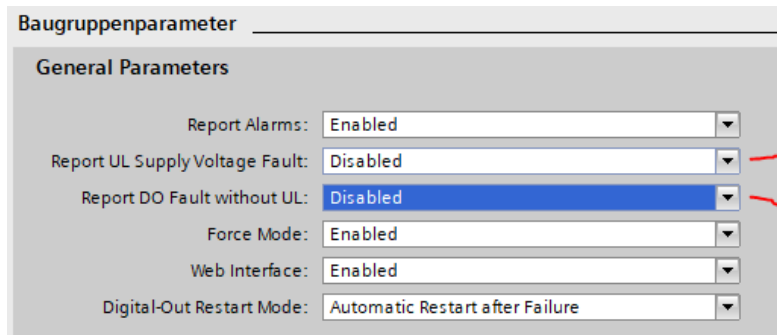
For this module, you have these two options which you can check:

The option 1 deactivates the error propagation for UL Power Supply in upstream.

The option 2 deactivates the error propagation for UL Power Supply in the downstream

This could probably be a workaround for your problem.
