## How to manage UL Power Supply for Lumberg Active Components

Carmine D'Errico - 2019-08-22 - How-to articles

<b><i>Affected Modules</i></b>	0980 ESL 390-1x1
<b><i>Network type</i></b>	Profinet
<b><i>PLC</i></b>	Siemens

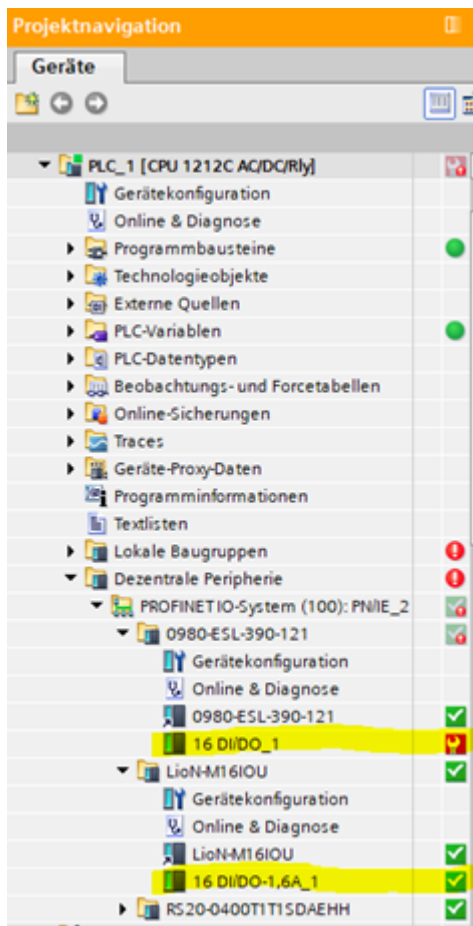
Now we switch off the UL Power Supply for both the modules

We notice that module 0980 ESL 390-1x1 shows an error. These are the reasons:

- The module provides an option to manage the error propagation for **UL upstream power supply**
- The module provides the option to manage the propagation **UL Power Supply error for downstream components**

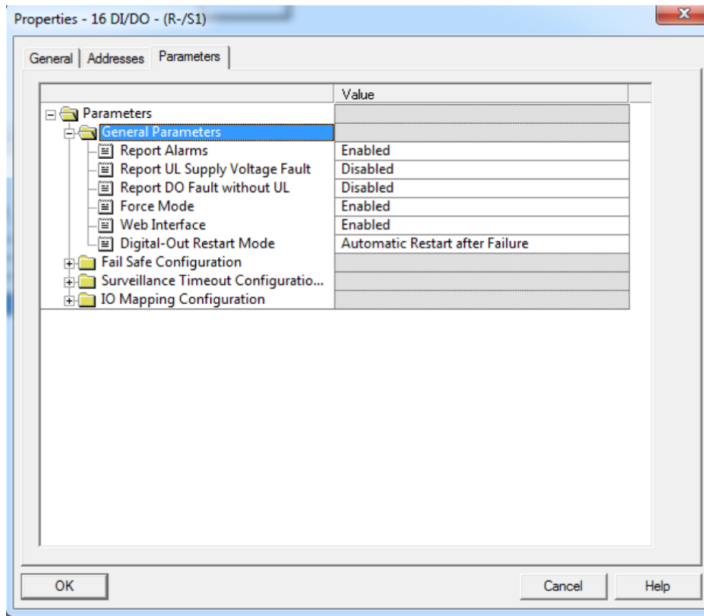
No Diagnosis without UL and activated Output

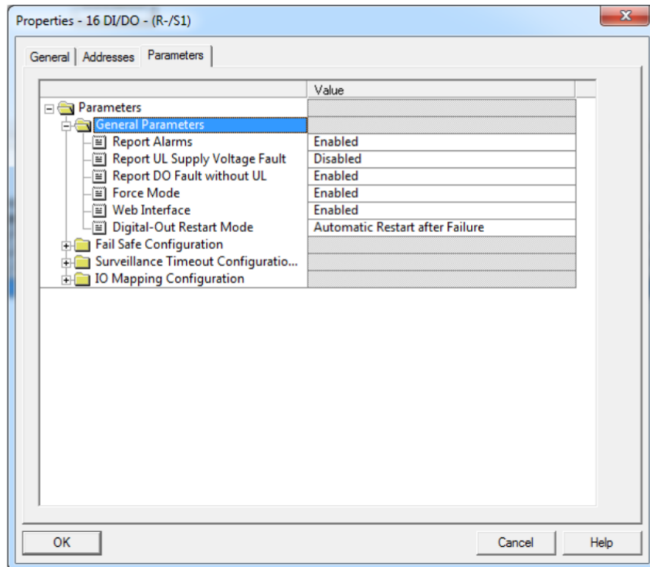
Diagnosis without UL only for activated Output

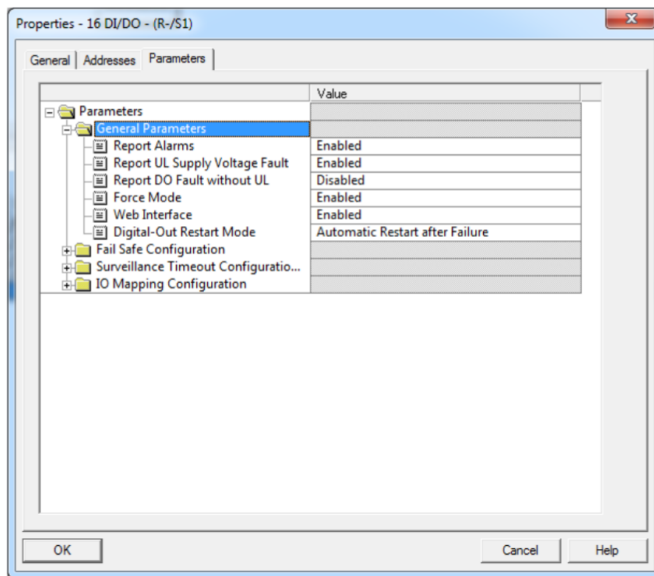
UL diagnosis when off or below 18V
