How to manage UL Power Supply for Lumberg Active Components

Carmine D'Errico - 2019-08-22 - How-to articles

Affected Modules	0980 ESL 390-1x1
Network type	Profinet
PLC	Siemens

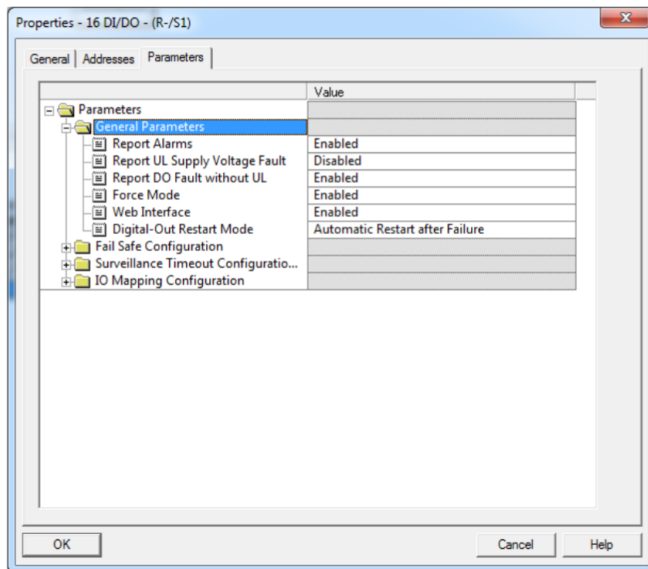
Diagnosis without UL only for activated Output
