How to manage UL Power Supply for Lumberg Active Components

Carmine D'Errico - 2019-08-22 - How-to articles

Affected Modules 0980 ESL 390-1x1

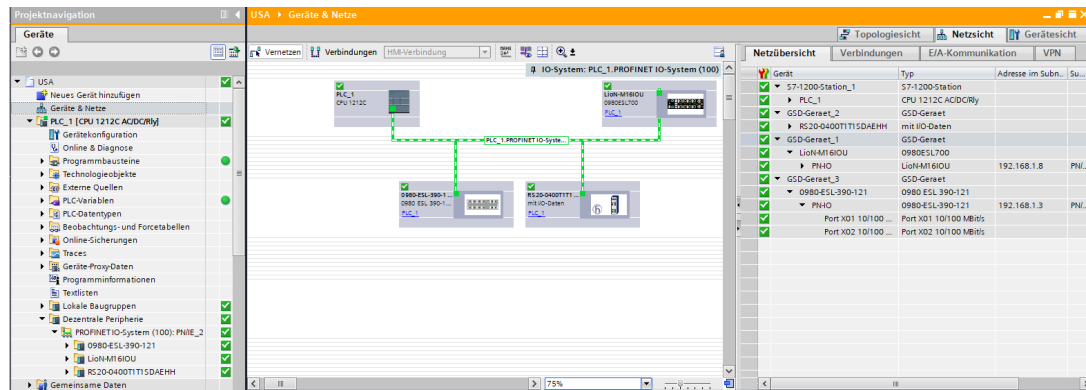
Here we build up a network with all the U_L power supply. NO ERROR APPEARS.

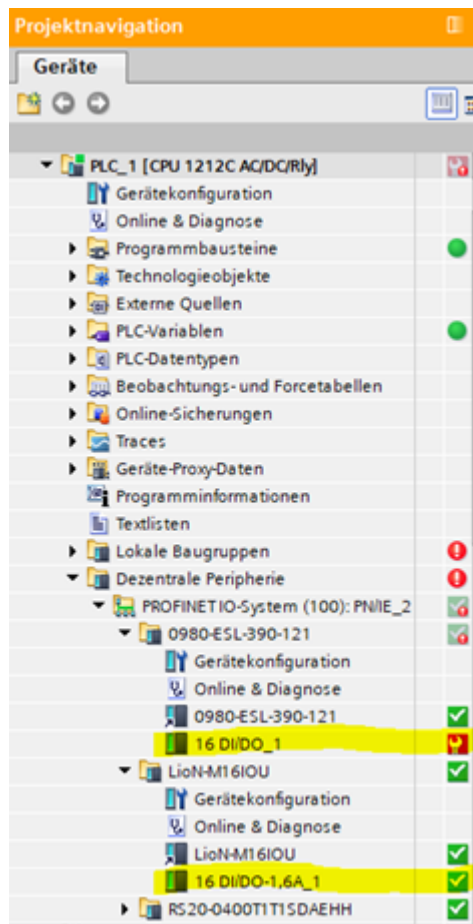
Now we switch off the U_L Power Supply for both the modules

We notice that module 0980 ESL 390-1x1 shows an error. These are the reasons:

- The module provides an option to manage the error propagation for ***U_L upstream power supply***
- The module provides the option to manage the propagation ***U_L Power Supply error for downstream components***
