## How to manage UL Power Supply for Lumberg Active Components

<b>Affected Modules</b>	0980 ESL 390-1x1
<b>Network type</b>	Profinet
<b>PLC</b>	Siemens

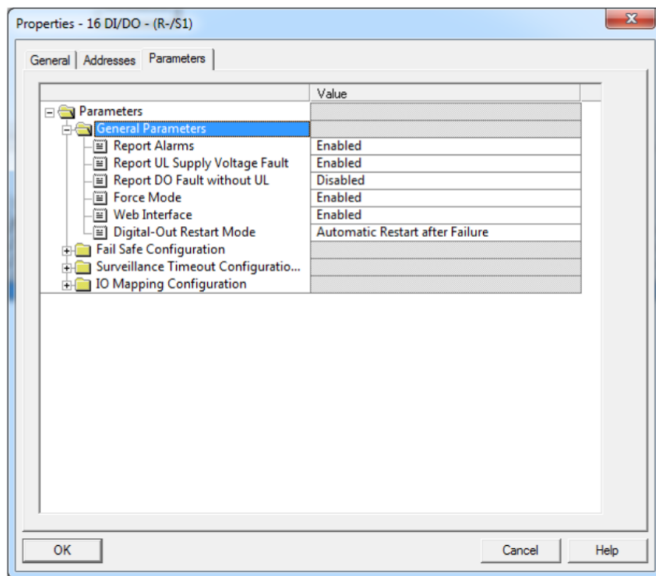
UL diagnosis when off or below 18V
