How to manage UL Power Supply for Lumberg Active Components

Carmine D'Errico - 2019-08-22 - How-to articles

Affected Modules 0980 ESL 390-1x1

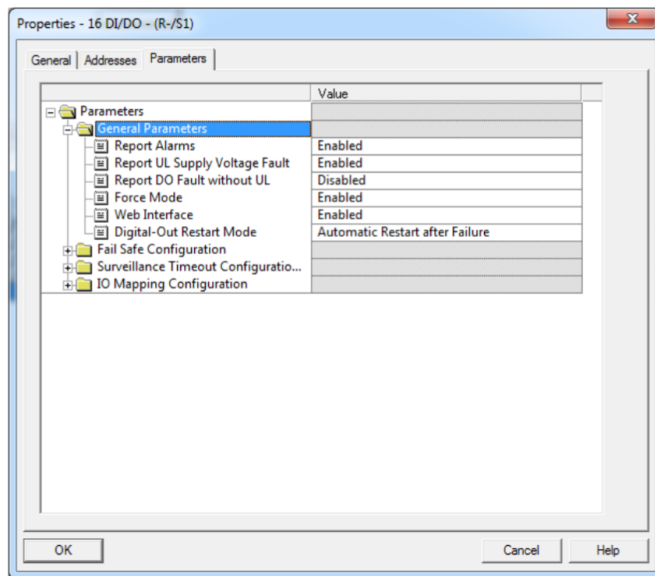
UL diagnosis when off or below 18V
