## How to manage UL Power Supply for Lumberg Active Components

Carmine D'Errico - 2019-08-22 - How-to articles

**Affected Modules** 0980 ESL 390-1x1

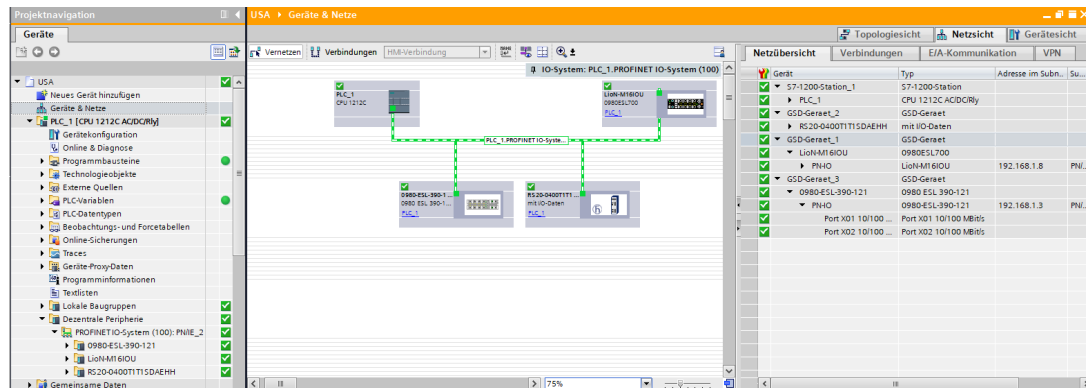
Here we build up a network with all the  $U_L$  power supply. NO ERROR APPEARS.
