## How to manage UL Power Supply for Lumberg Active Components

Carmine D'Errico - 2019-08-22 - How-to articles

<b><i>Affected Modules</i></b>	0980 ESL 390-1x1
<b><i>Network type</i></b>	Profinet
<b><i>PLC</i></b>	Siemens

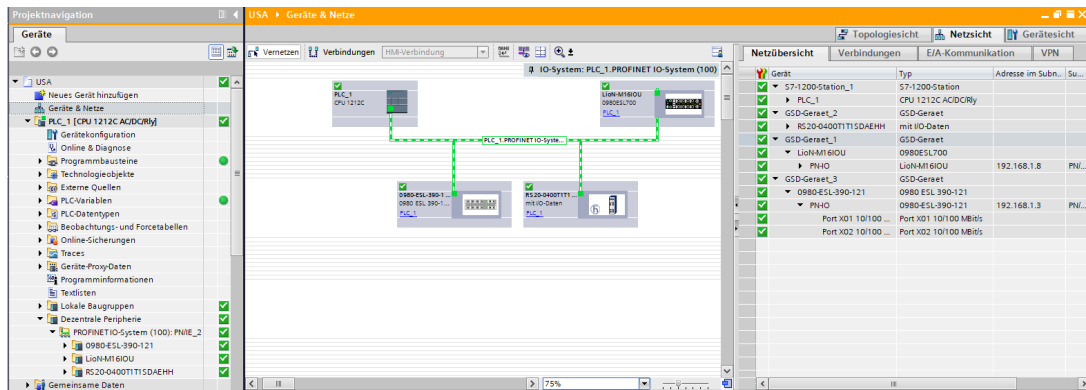
Here we build up a network with all the  $U_L$  power supply. NO ERROR APPEARS.

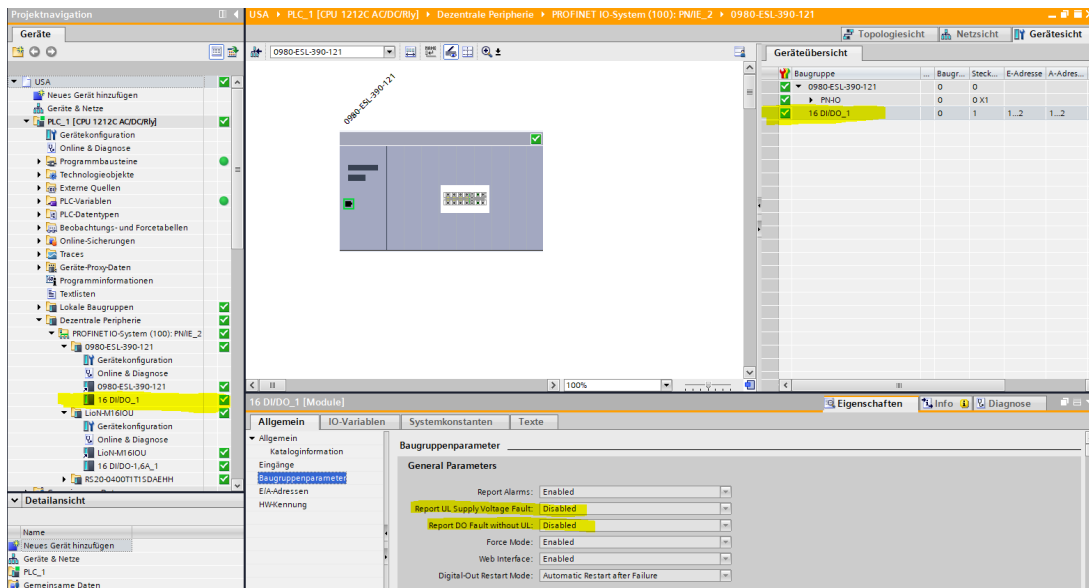
The option 1 deactivates the error propagation for UL Power Supply in upstream.

The option 2 deactivates the error propagation for UL Power Supply in the downstream

This could probably be a workaround for your problem.
