How to manage UL Power Supply for Lumberg Active Components

Carmine D'Errico - 2019-08-22 - How-to articles

Affected Modules 0980 ESL 390-1x1

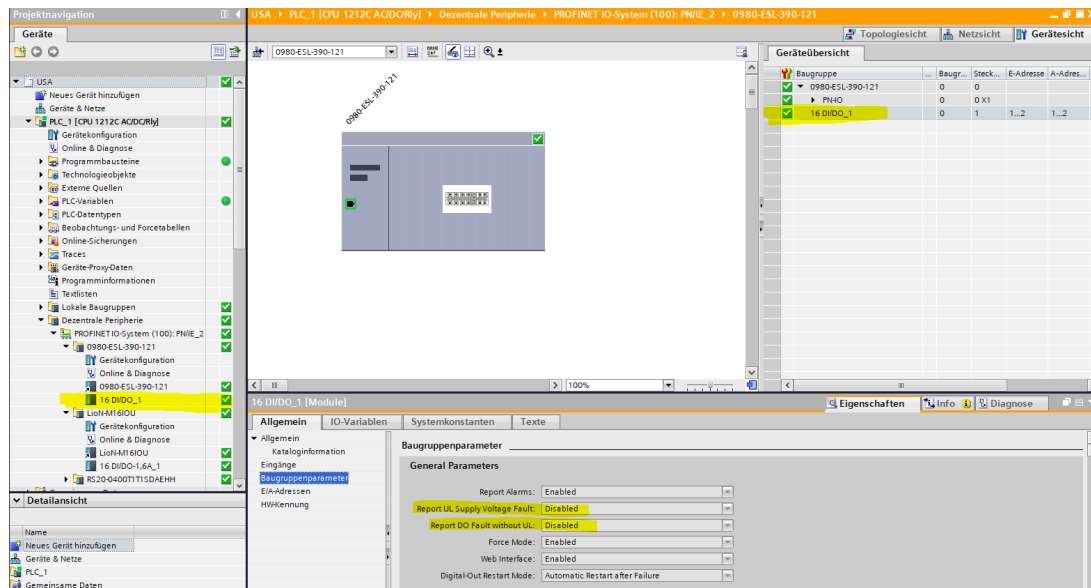
The option 1 deactivates the error propagation for UL Power Supply in upstream.

The option 2 deactivates the error propagation for UL Power Supply in the downstream

This could probably be a workaround for your problem.
