## How to manage UL Power Supply for Lumberg Active Components

<b>Affected Modules</b>	0980 ESL 390-1x1
<b>Network type</b>	Profinet
<b>PLC</b>	Siemens

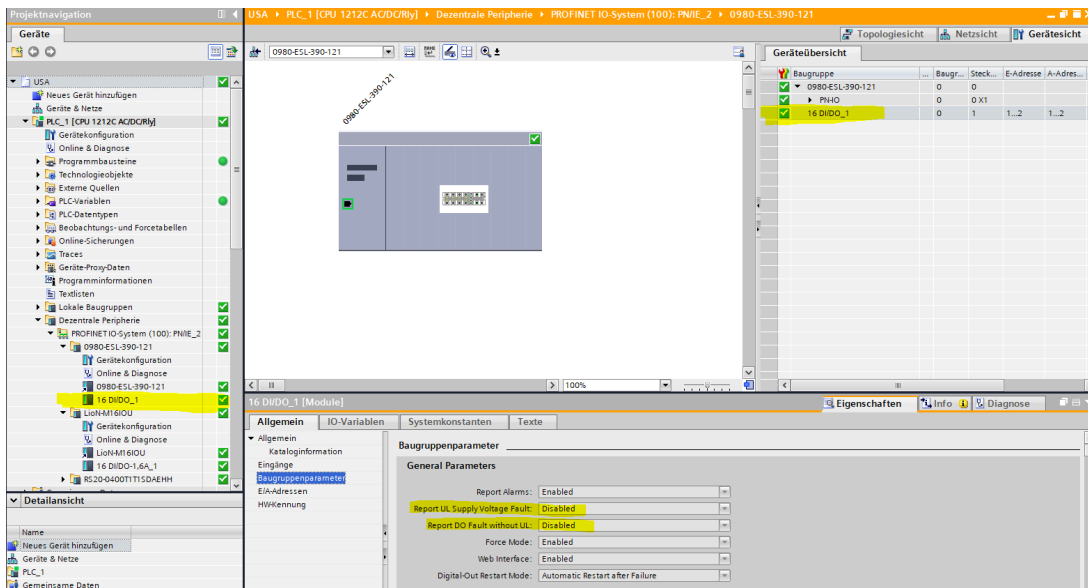
The option 1 deactivates the error propagation for UL Power Supply in upstream.

The option 2 deactivates the error propagation for UL Power Supply in the downstream

This could probably be a workaround for your problem.
