Tips to Ensure Successful REVConnect Installation

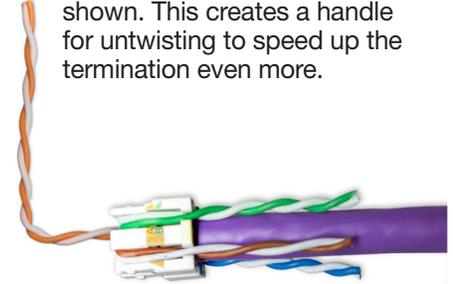
- 5.** When untwisting pairs, bend each pair into an “L” shape as shown. This creates a handle for untwisting to speed up the termination even more.

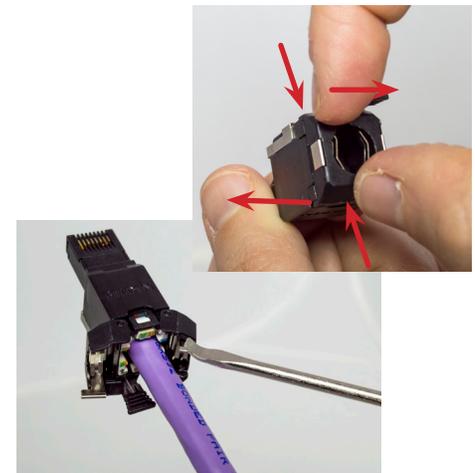
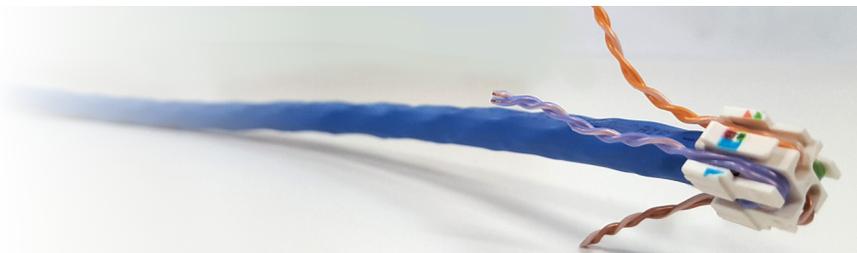
- 6.** When removing a terminated core from a plug or shielded jack with doors, open the rear doors by depressing the metal “squares” on the sides of the doors. Then, squeeze vertically on the upper and lower pins and pull your fingers apart. Lift on the latch with a small screwdriver (or the Belden outlet release tool) and pull the cable out.
